State Route 138 (between Jct 18/138 and Crest Forest Drive) upper slope damage. Shows area of continuing slide on upper slope. (February 24, 2005)

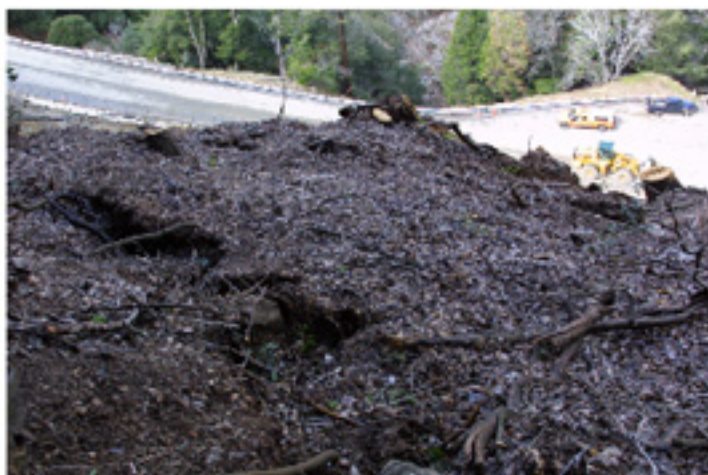
State Route 138  
(between Jct 18/138 and Crest Forest Drive)  
upper slope damage. This crevice is over 100 feet wide  
located about 350 feet above SR-138  
(February 24, 2005)

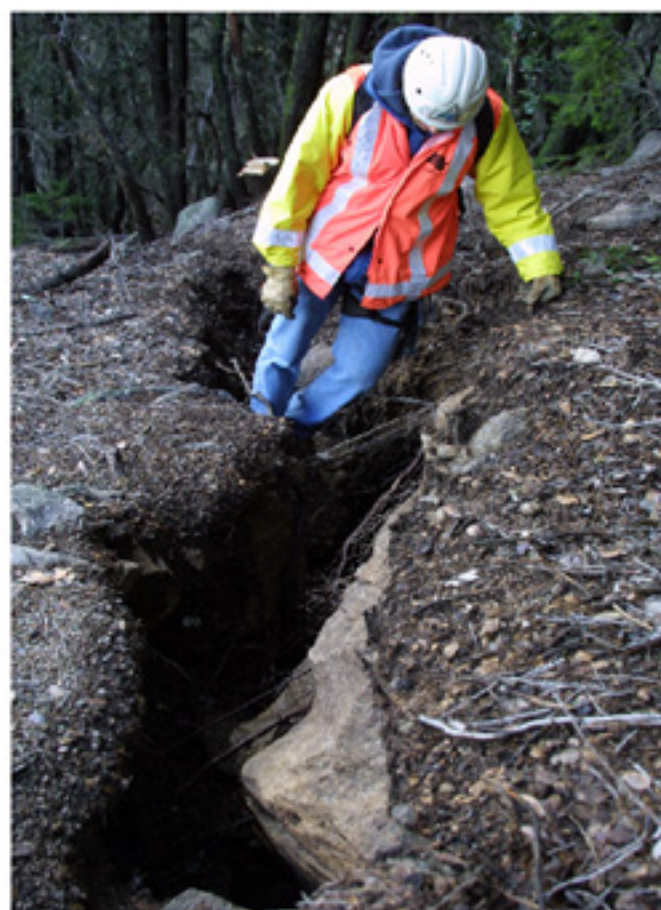
State Route 138  
(between Jct 18/138 and Crest Forest Drive)  
upper slope damage. Shows depth of crevice  
- over four foot deep. (February 24, 2005)
